**Investigation of Australian Tubeworm, *Ficopomatus enigmaticus*, in
the Tralee Ship Canal**

AQUAFAC International Services Ltd

Tralee Rowing Club

October 2021

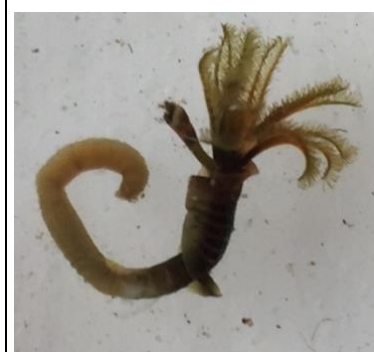
**Figure 1. *F. enigmaticus*
without tube**

F. enigmaticus is a relatively small (up to c.50mm) sedentary polychaete worm with a symmetrical body. It secretes a calcareous tube within which it lives (see Figure 1.).

The tube is large enough to protect its entire body and it grows in length as the worm secretes new tube-forming material at the opening. *F. enigmaticus* has the typical segmented body form of true worms. A fan of tentacles at the anterior end of the body is found at the opening of the tube which it extends and uses to filter water for its food and it also serves in gas exchange. One of the tentacles is specialised to provide a plug like operculum which is used to seal the tube into which it withdraws for protection.

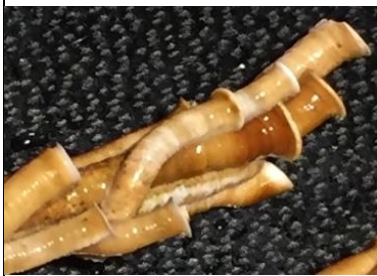
Figure 2. *F. enigmaticus* tubes

The surface of the worm's calcareous tube has characteristics ring/flange features at intervals along its otherwise smooth length (See Figure 2.). The tube also has a coating of chitin that protects it from erosion.

Individuals have the habit of settling together to create large colonies. As an individual worm grows its tube is at first recumbent on the surface on which it settles but then rises from the surface as it grows in length. This growth behaviour has the effect of the colony creating a structure that provides a lot of open spaces that other species can take refuge within. A colony can form a mat of many

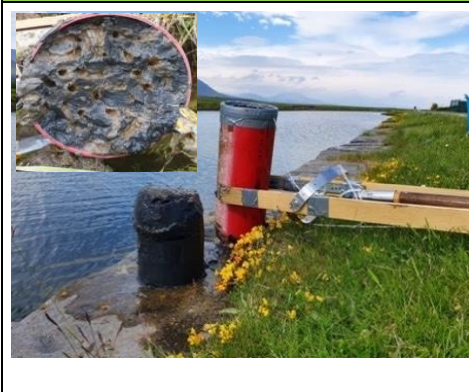
Figure 3. Core sampler with inset of 15 cm cross section.

A purpose-built self-inverting core sampler (diameter - 15cm; sample Area - 175cm² and penetration – 30+ cm) was developed, tested and was found to be suited to the conditions along the full length of the canal for soft sediment sampling (See Figure 2. Note insert indicating

burrows of *H. diversicolor* at 15+ cm). This was operated from a boat by means of an extendable pole allowing sampling in water depth of up to 6m which was adequate for the depth range encountered and especially in the deepest section close to the lock gates. Trials showed that the sampler produced approximately double the amount of infauna that the grab sampler produced in areas where the fauna was moderately deeply buried and the discrepancy was even greater where fauna was more deeply buried. In the latter areas the grab sampler would have failed to retrieve representative samples of the infauna.

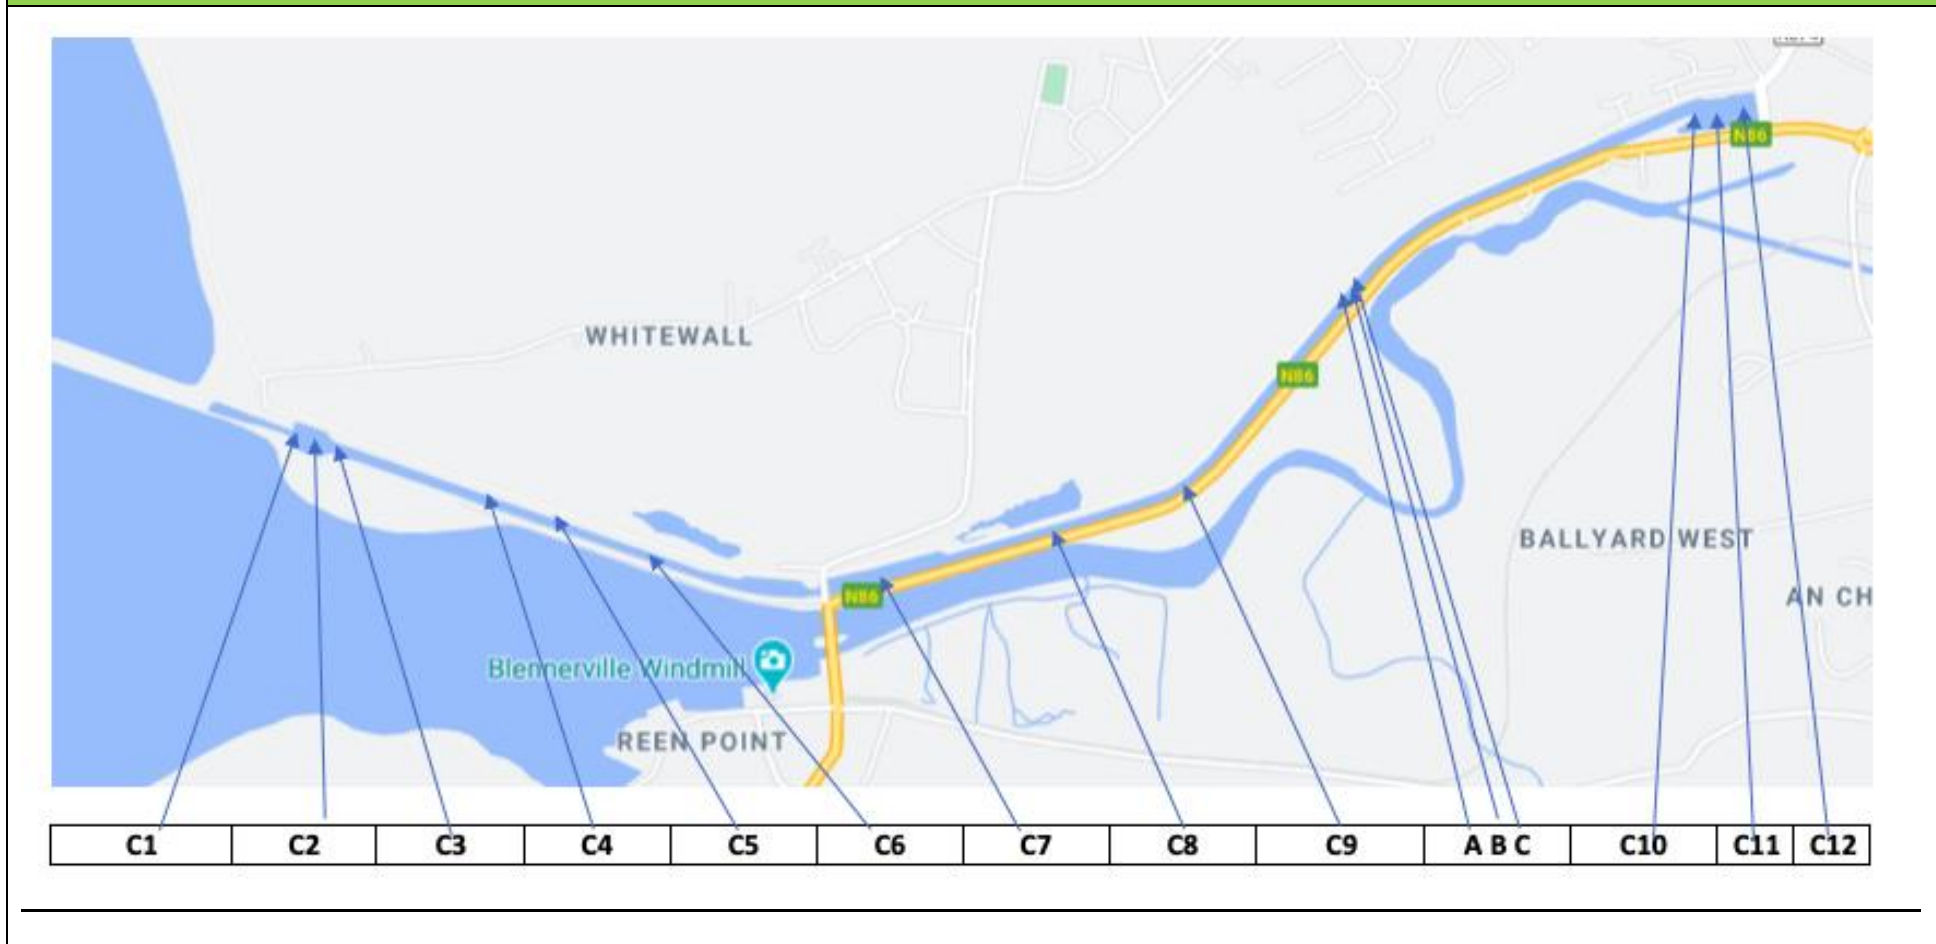
Figure 4. Location of samples from centre line of canal (C1-12) and from pocket of sediment in damaged N wall close to surface (A,B,C)

Samples were taken for granulometry from 5 locations; four sampling points were located along the center-line of the canal (C1, C4, C7, and C10) and one was taken from a pocket of sediment created in a damaged section of the canal wall on the north side c. 750m from the canal basin (B). This latter sample was taken as this and similar pockets of sediment in areas of damage to the canal wall were seen to be occupied by burrowing fauna.

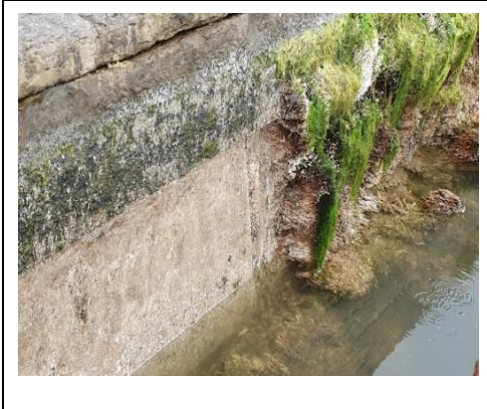
Figure 6. Section of *F. enigmaticus* removed from canal basin wall

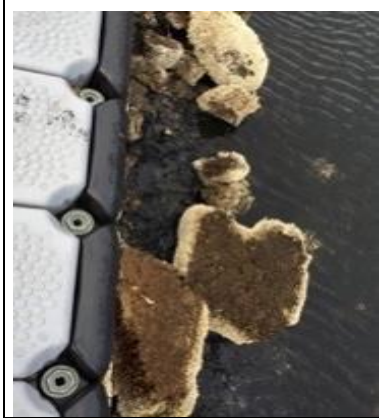
Figure 7. *F. enigmaticus* dislodged from TRC pontoon

Submerged surfaces of both pontoons were found to be completely covered with *F. enigmaticus* at the commencement of the survey. Following the drying out of the canal when the pontoons had come to rest of the bottom, much of the heavy tubeworm fouling was dislodged (see Figure 7), but there was evidence shortly afterwards of resettlement on the bare surfaces exposed by the dislodged tubeworm masses.

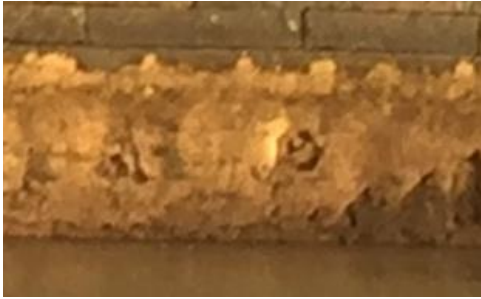
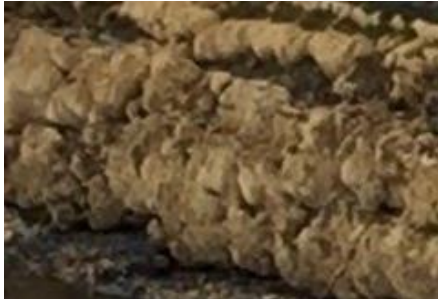
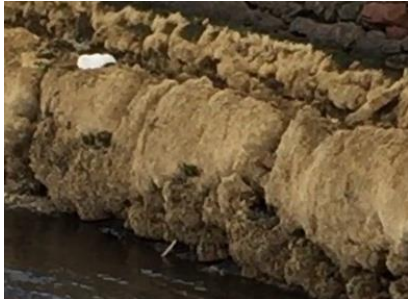
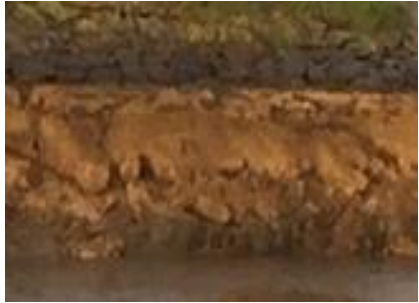
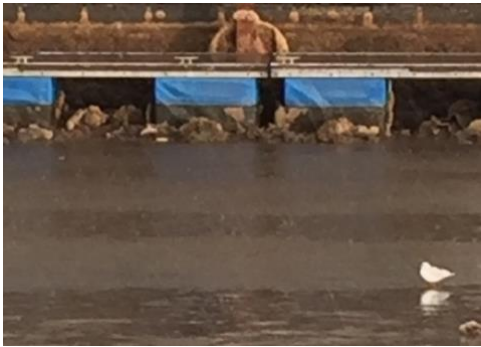
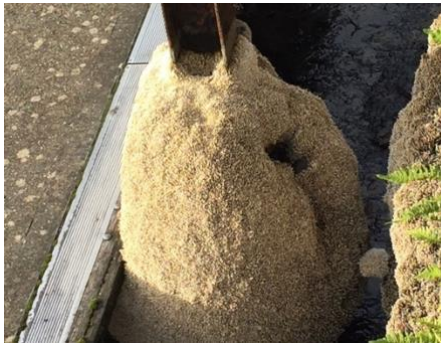
Figure 9. % Coverage by *F. enigmaticus* of walls and structures within the canal basin

<p>North Wall - 90-95%</p>

<p>South Wall - 80-90%</p>

<p>East Wall - 80-90%</p>

<p>West Wall - 90-95%</p>

<p>Marina Pontoon - 90-95%</p>

<p>Marina Pontoon Pile - 100%</p>

The occurrence of *F. enigmaticus* within the canal basin itself sees the prevalence of large clumps growing along the canal wall from the surface to a depth of 1.5+ m where it meets the muddy bottom. This was typically a growth of c. 0.2 m in thickness along much of the 250+m length of the canal basin wall. Spherical lumps was found growing on the hard surface of debris scattered along the bottom of the canal basin, some of which are up to 0.7m - 0.8 m in diameter (See Figure 9).

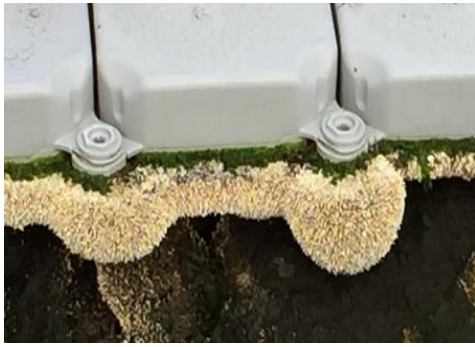
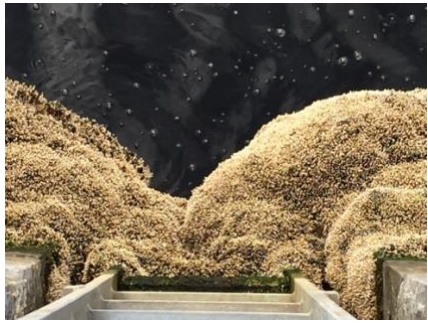
<p>TRC Pontoon - 90-100%</p>

<p>Base of Ladder - 100%</p>

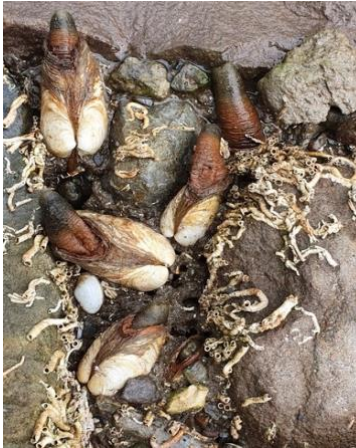
Figure 13. Sand Gapers emerging from gaps between canal wall stone armour

The presence of the Sand Gaper (*M. arenaria*) living in the gaps between the stone armour on the walls in the upper reaches of the canal was not obvious on cursory inspection. The gaps in

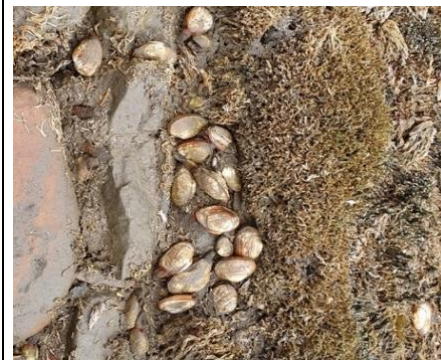
Figure 14. Emerged Sand Gapers lying exposed at base of canal wall

Some of these were preyed on and their empty shells were found around the area. Others survived the long exposure and seemed to revive when water returned, ever after prolonged exposure. No estimate of the level of mortality was made but many of those that emerged and survived did not manage to return to the mud as the ability to burrow from the surface seems to be lacking in large

adult specimens. These specimens continued to live, for a time at least, exposed on the surface of the side wall or on the mud.

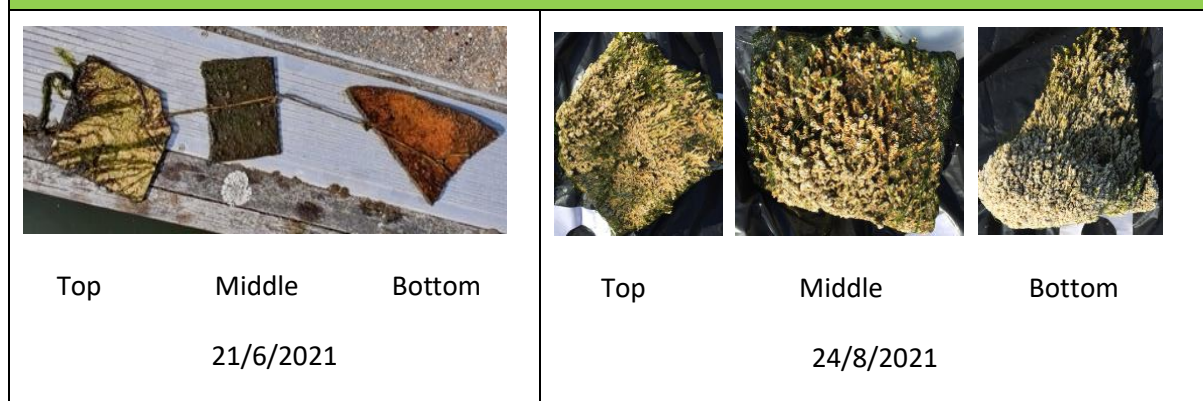
Figure 15. Growth of *F.e* over period from 21st June to 24th August on Spat Collector Tiles

Figure 15 shows the growth of algae that settled on the spat collector tiles in the period from mid-April when algae was first noticed to mid-June. *F. enigmaticus* was slow to appear alongside a small number of a barnacle, *Balanus crenatus*, amongst the algal which has covering most of the surface of the tiles by this time. The period from mid-June to mid-July saw the entire surface area of the three tiles being covered with a recumbent mat of *F. enigmaticus* and the effective displacement of the algae and the *B. crenatus*. Growth continued and resulted in all the settled specimens growing to adult

size in less than two months. By the end of August the specimens displayed additional growth and what was initially a recumbent mat of tubeworms progressed to become clusters of individuals rising from the surface of the tiles to produce the typical clump of individuals. This was especially pronounced on the lowest tile in the set and particularly on the bottom part of this tile.

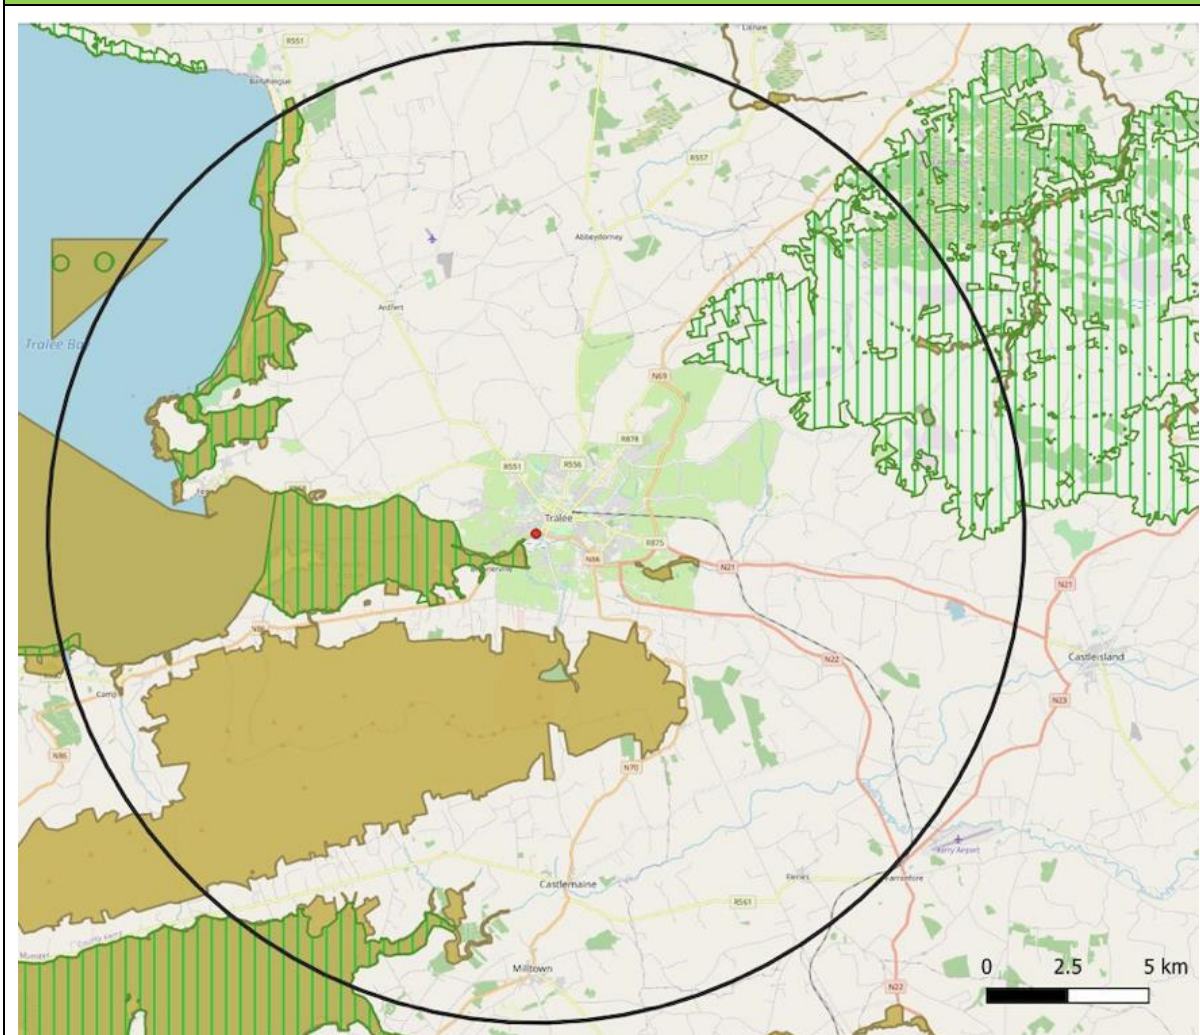
Figure 17 . Natura 2000 sites (SAC- brown, SPA- green) located within a 15km radius of the Tralee Ship Canal.

Figure 17 below shows the Natura 2000 sites within a 15km radius of the Tralee Ship Canal. Table 17 lists the 11 sites and only two of these have a hydrological/ecological connection with the canal. For this reason the other nine sites are excluded from further consideration in terms of potential for significant impact on the conservation interests from the proposed project.

Tralee Bay and Magharees Peninsula, West to Cloghane SAC (002070) and the Tralee Bay Complex SPA (004188) are the only two sites relevant in the context of this project.
